LLNL-TR-458480

Performance Analysis: Control of Hazardous Energy

**Occurrences and Associated Noncompliances
Discovered
January 2008–August 2010**

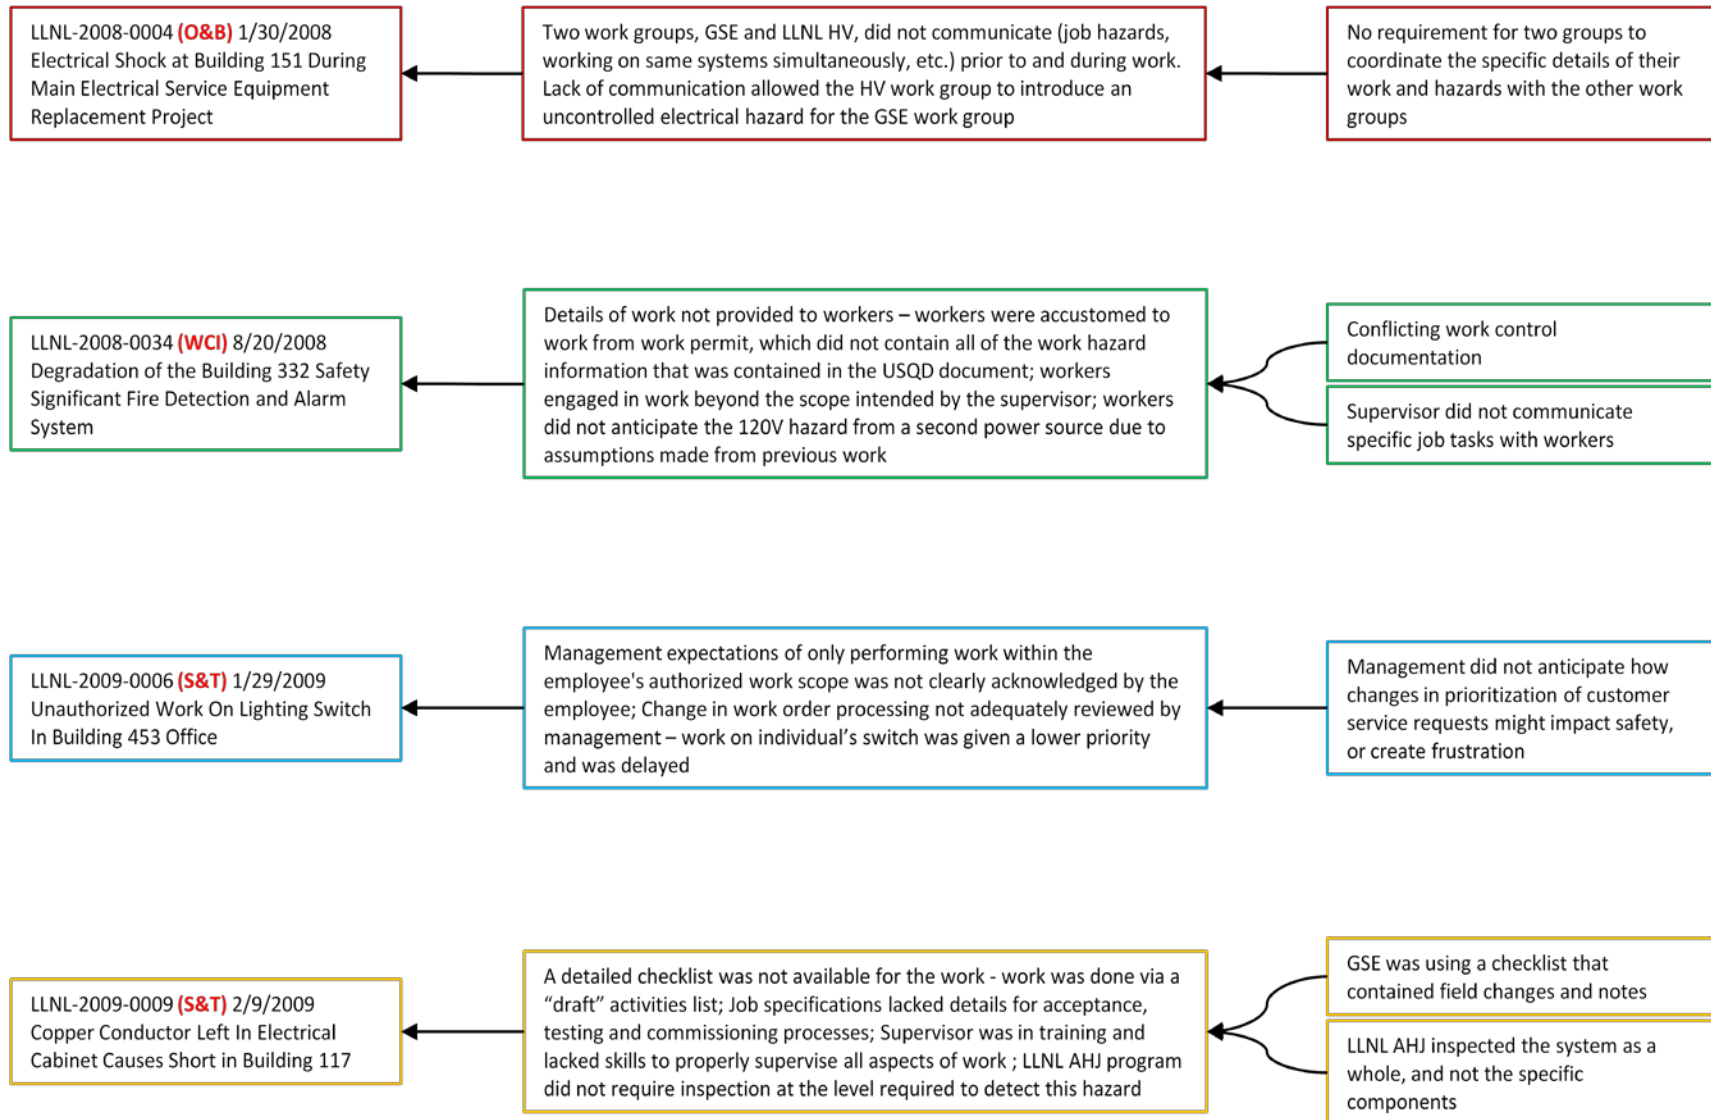
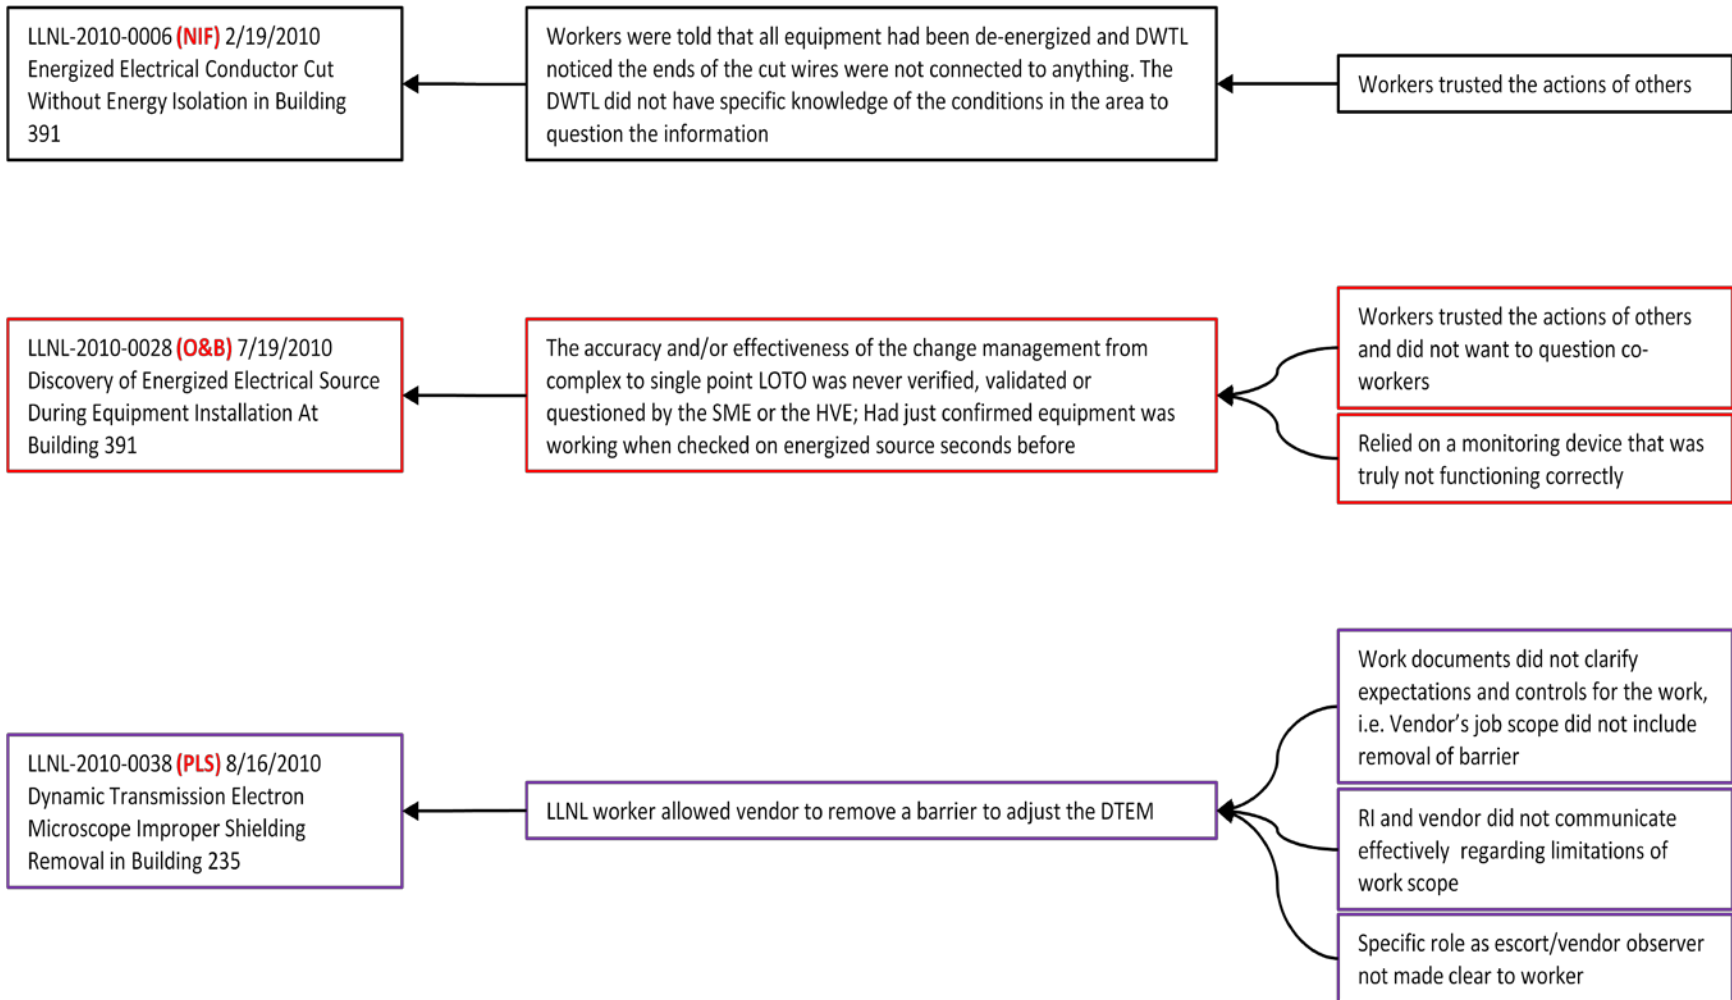
Figure 6. Common Cause Analysis of Events related to ISM Function 1: Define Work

The causes of the specific occurrences were identified by the owning organization and initially appear to be distinct. But, in taking the collective view, there are common themes. For example, work control documents being used to guide the work sometimes conflicted with other documents, policies or guidance; work groups did not coordinate work or communicate to de-conflict work on the same systems; changes in work scope or hazards were not identified and addressed; and checklists that were in a “draft” form were used to define the work.

The cause for some events was the fact that workers were given misinformation and often trusted other workers, or trusted that the work that was done preceding their work was done correctly. This trust is embedded in professional courtesy and culture, but sometimes lends itself to opportunities to overlook hazards or work outside of the designated work scope. Some work processes did not include steps or tools to verify the status of hazardous energy. Three events in this ISM functional area have causes that suggest a reliance or trust on the actions of others. One recent event is of particular note: In the “Discovery of Energized Electrical Source During Equipment Installation At Building 391,” OR # LLNL-2010-0028, a questioning attitude (or verification process) was absent by the work supervisor, which led to irregularities in the work to go unchecked – this worker trusted the actions of the others. This event also had a cause related to using a defective monitoring device critical to the LOTO process – a multi-meter that had a bad probe connection was used to check for the absence of voltage on the equipment, but the LOTO steps were not followed completely, giving a false reading of “no voltage.”

In another event, where a copper conductor was inadvertently left in an electrical cabinet causing a short circuit, a draft checklist that contained field notes and hand-written changes was used in the field. Also, at the completion of work by the subcontractor, the LLNL AHJ inspected this system as a whole, but did not inspect specific components for hazards. Not looking at specific equipment allowed the copper conductor to go unnoticed.

There were communication issues in two events in the area. In one event, “Electrical Shock at Building 151 During Main Electrical Service Equipment Replacement Project,” LLNL OR # LLNL-2008-0004, one work group was working upstairs, and another group working downstairs, on the same buss duct equipment. The group upstairs introduced a current into the windings of a transformer that was connected to the equipment that was being worked on downstairs. The two groups were aware of each other’s presence; but, the groups didn’t coordinate the specific details of their work and hazards with the other work groups.

It appears that there are commonalities in the causes of these events. In all of these occurrences, there was insufficient or erroneous communication between work groups or between manager and worker.

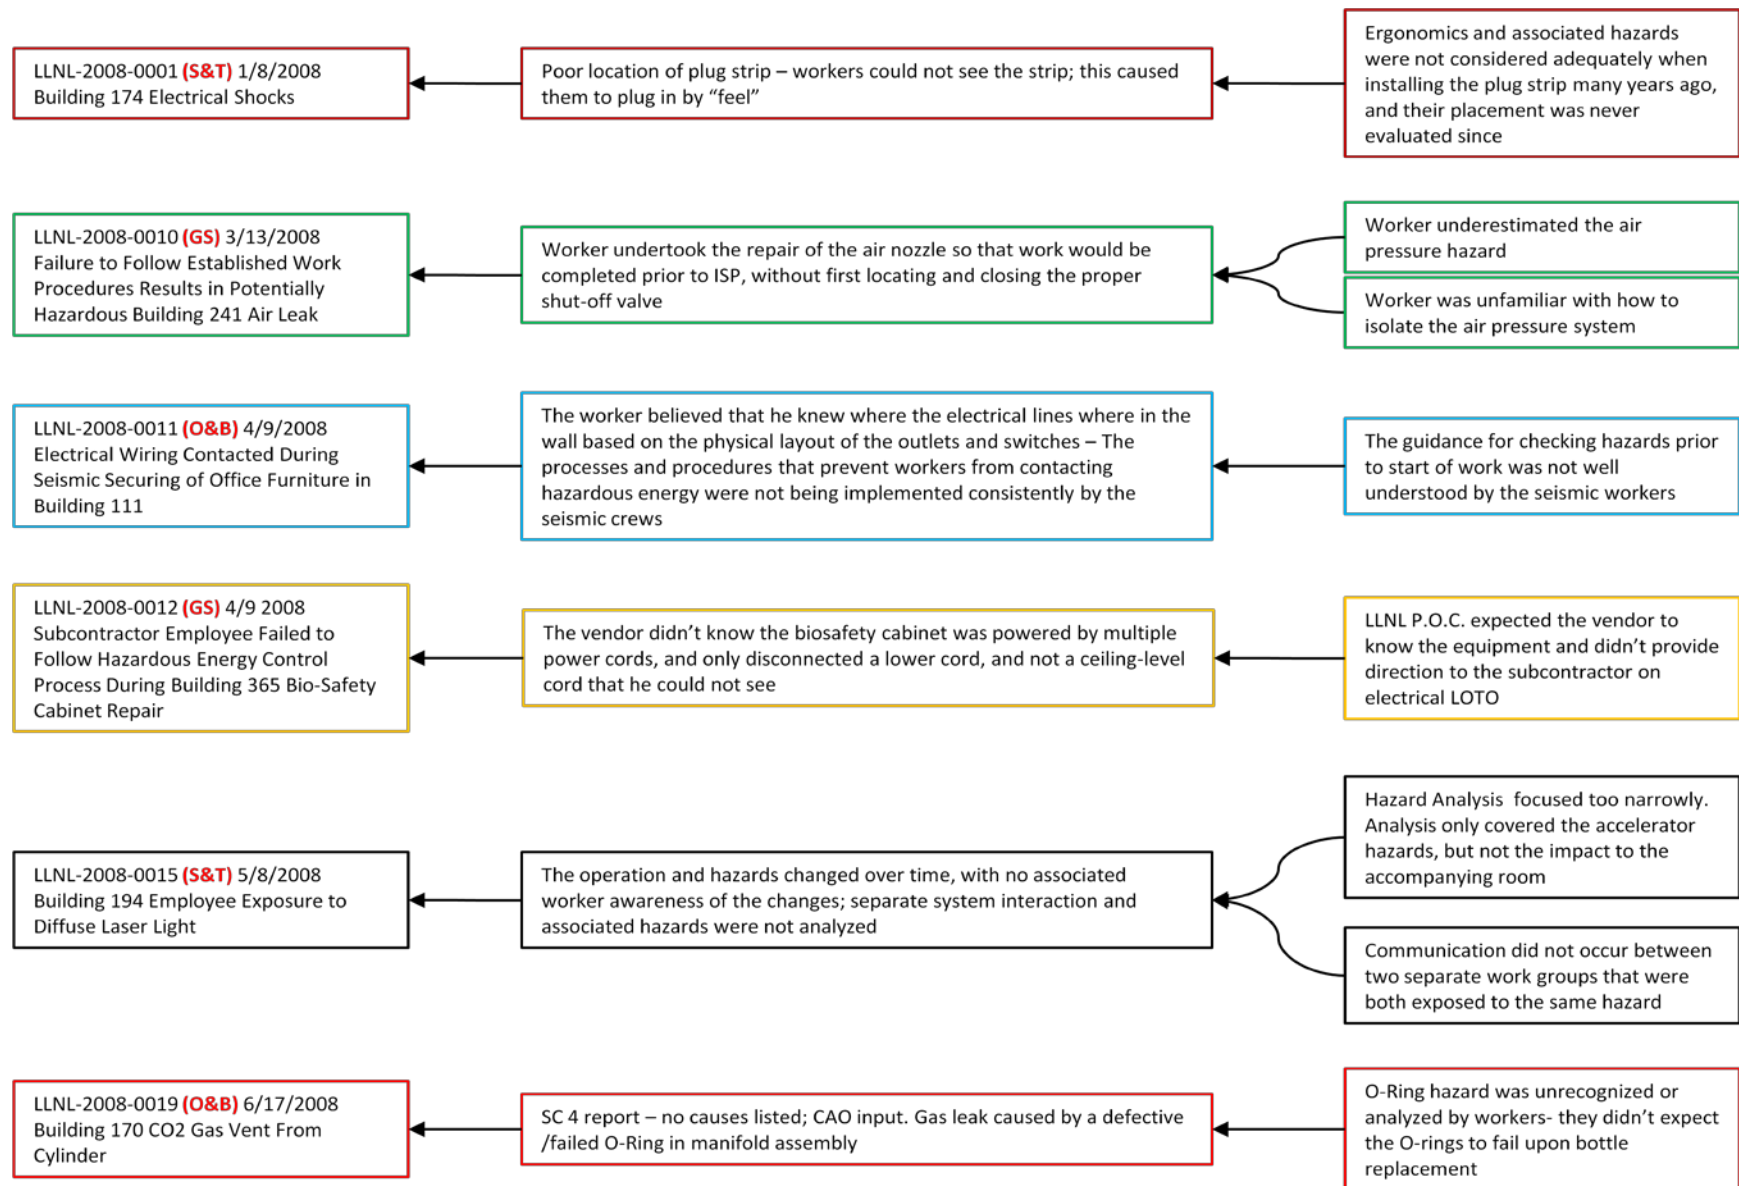
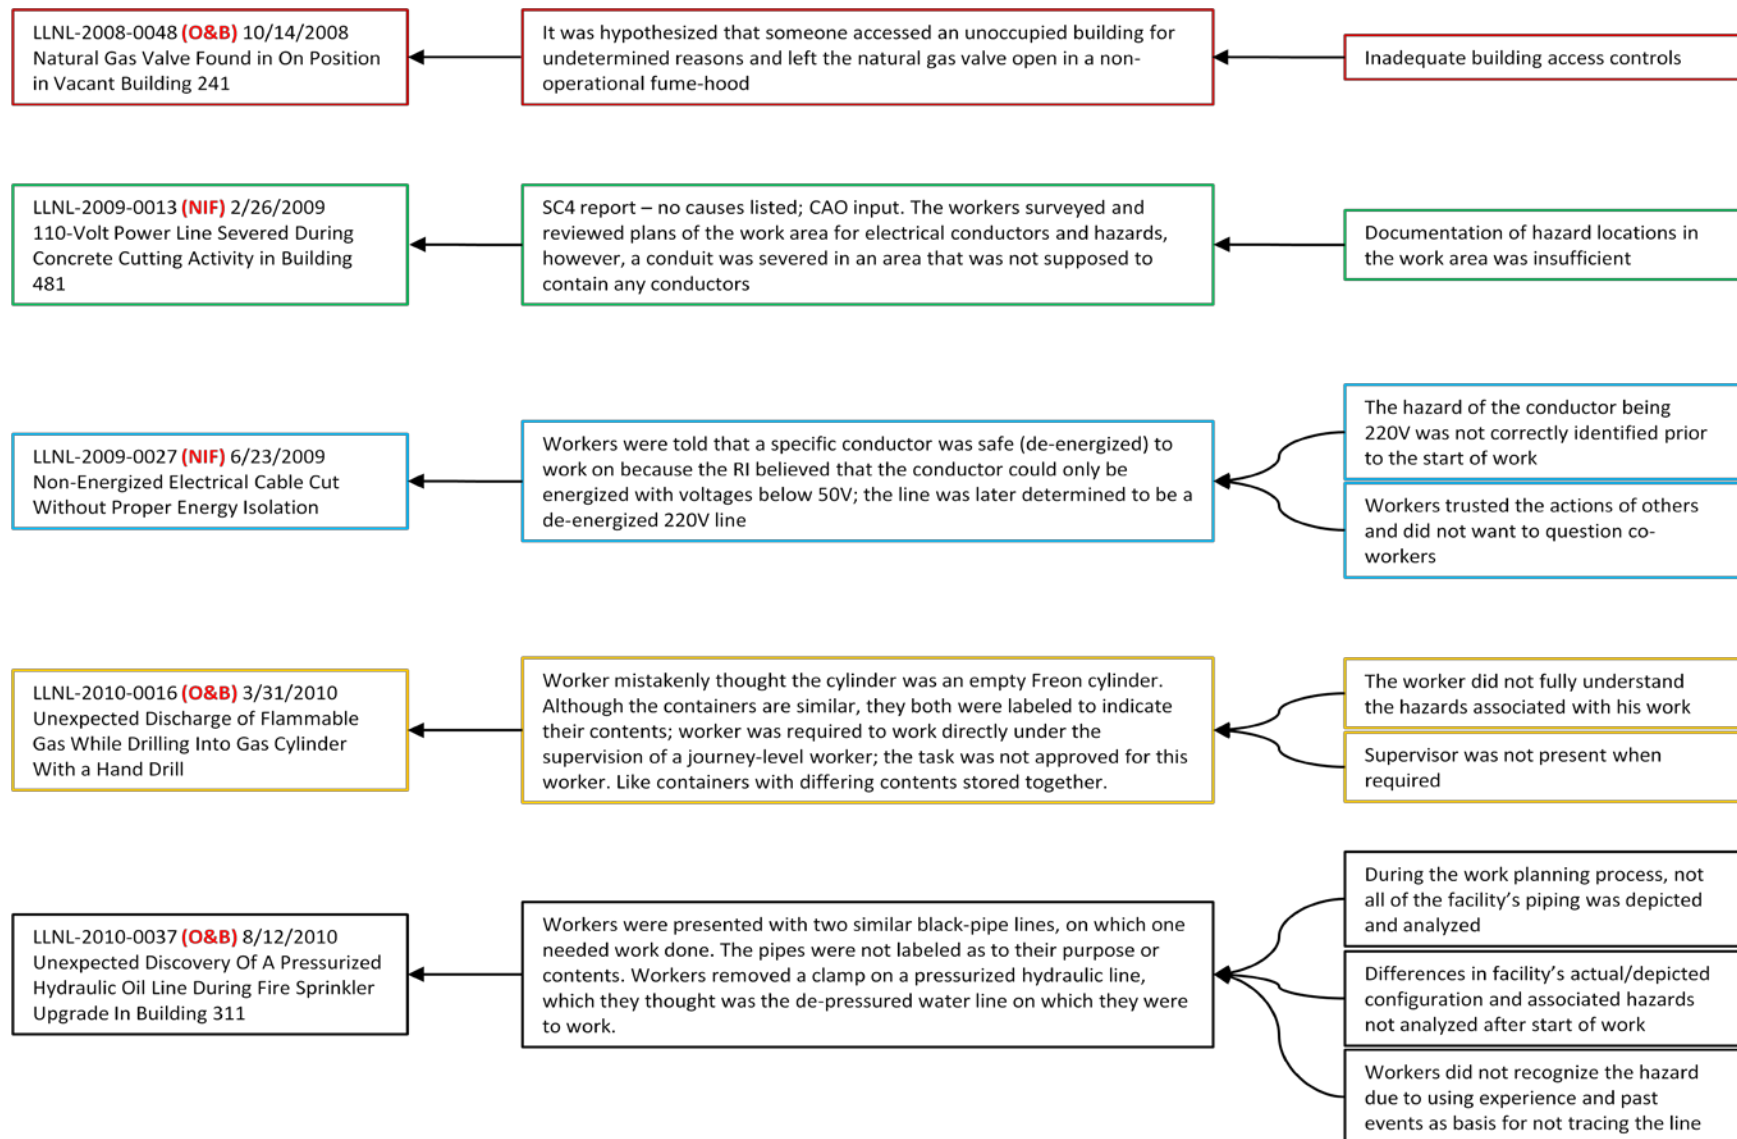
Figure 7. Common Cause Analysis of Events related to ISM Function 2: Analyze Hazards

In one event, a plug strip installation in an older building was the cause of two separate 120V shocks within a one-month period. The plug strip was installed in such a way that the workers could not see the strip - they were required to plug in cords by “feel” only. In these events, the worker’s fingers contacted the plug blades while they were plugging into the strip. The ergonomics of the installation were inadequate when it was installed, and the configuration was not re-evaluated – the hazard went unnoticed until the shocks.

In another event, a worker encountered a problem with a house air source coupling, and decided that he could repair it in order to complete his work before being laid-off the next day. When he removed the bad coupling, the house air system sensed a reduction in air pressure and started to build pressure to compensate. The worker attempted to install a replacement coupling, and when he could not, he thought to shut-off the air at the valve, but was unfamiliar with how to do that and found that the valves were stuck open. The underestimation of the air pressure hazard led to this event.

In another event, a worker seismically securing shelving in a building drilled into the wall without performing a scan of the wall to determine if he would contact live wires. It was determined that the processes and procedures that prevent workers from contacting hazardous energy were not being implemented consistently by the seismic crews - the guidance for checking hazards prior to start of work was not well understood by the seismic workers.

In yet another event, two workers were doing work in a room adjacent to an accelerator when it was operated. There was a pass-through tunnel between the two rooms that could allow the hazardous energy from one room to travel into the other room where unassociated, but simultaneous work was being conducted. The accelerator operation and hazards had changed over time, with no associated worker awareness of the changes, or consideration of the interactions of the separate systems and their associated hazards – these hazards were not analyzed.

In June of 2009, a non-energized electrical conductor was cut in Building 581. The responsible individual thought that the conductor was not energized with any energy above 50V, and therefore allowed work to progress. The line was later determined to be a 220V line, and the worker could have been exposed to 220V when using cutters to cut the conductor by hand. The hazard of the conductor being 220V was not correctly identified prior to the start of work and the workers trusted the actions of others and did not want to question co-workers.

In August of 2010, workers were doing upgrades to a fire sprinkler in Building 311. They were presented with two similar black-pipe lines, on which one needed work. The pipes were not labeled as to their purpose or contents. The workers removed a clamp on one of the black pipes, believing it to be the water line associated with their work, but instead, it was a pressurized hydraulic line. This hazard was not identified prior to the start of work.

It appears that there are commonalities in the causes. In nine of these occurrences, the hazards that would have been identified and analyzed during the course of performing the work were underestimated or not recognized by the workers. In the other two occurrences, the hazards were underestimated or not recognized prior to the work being authorized.

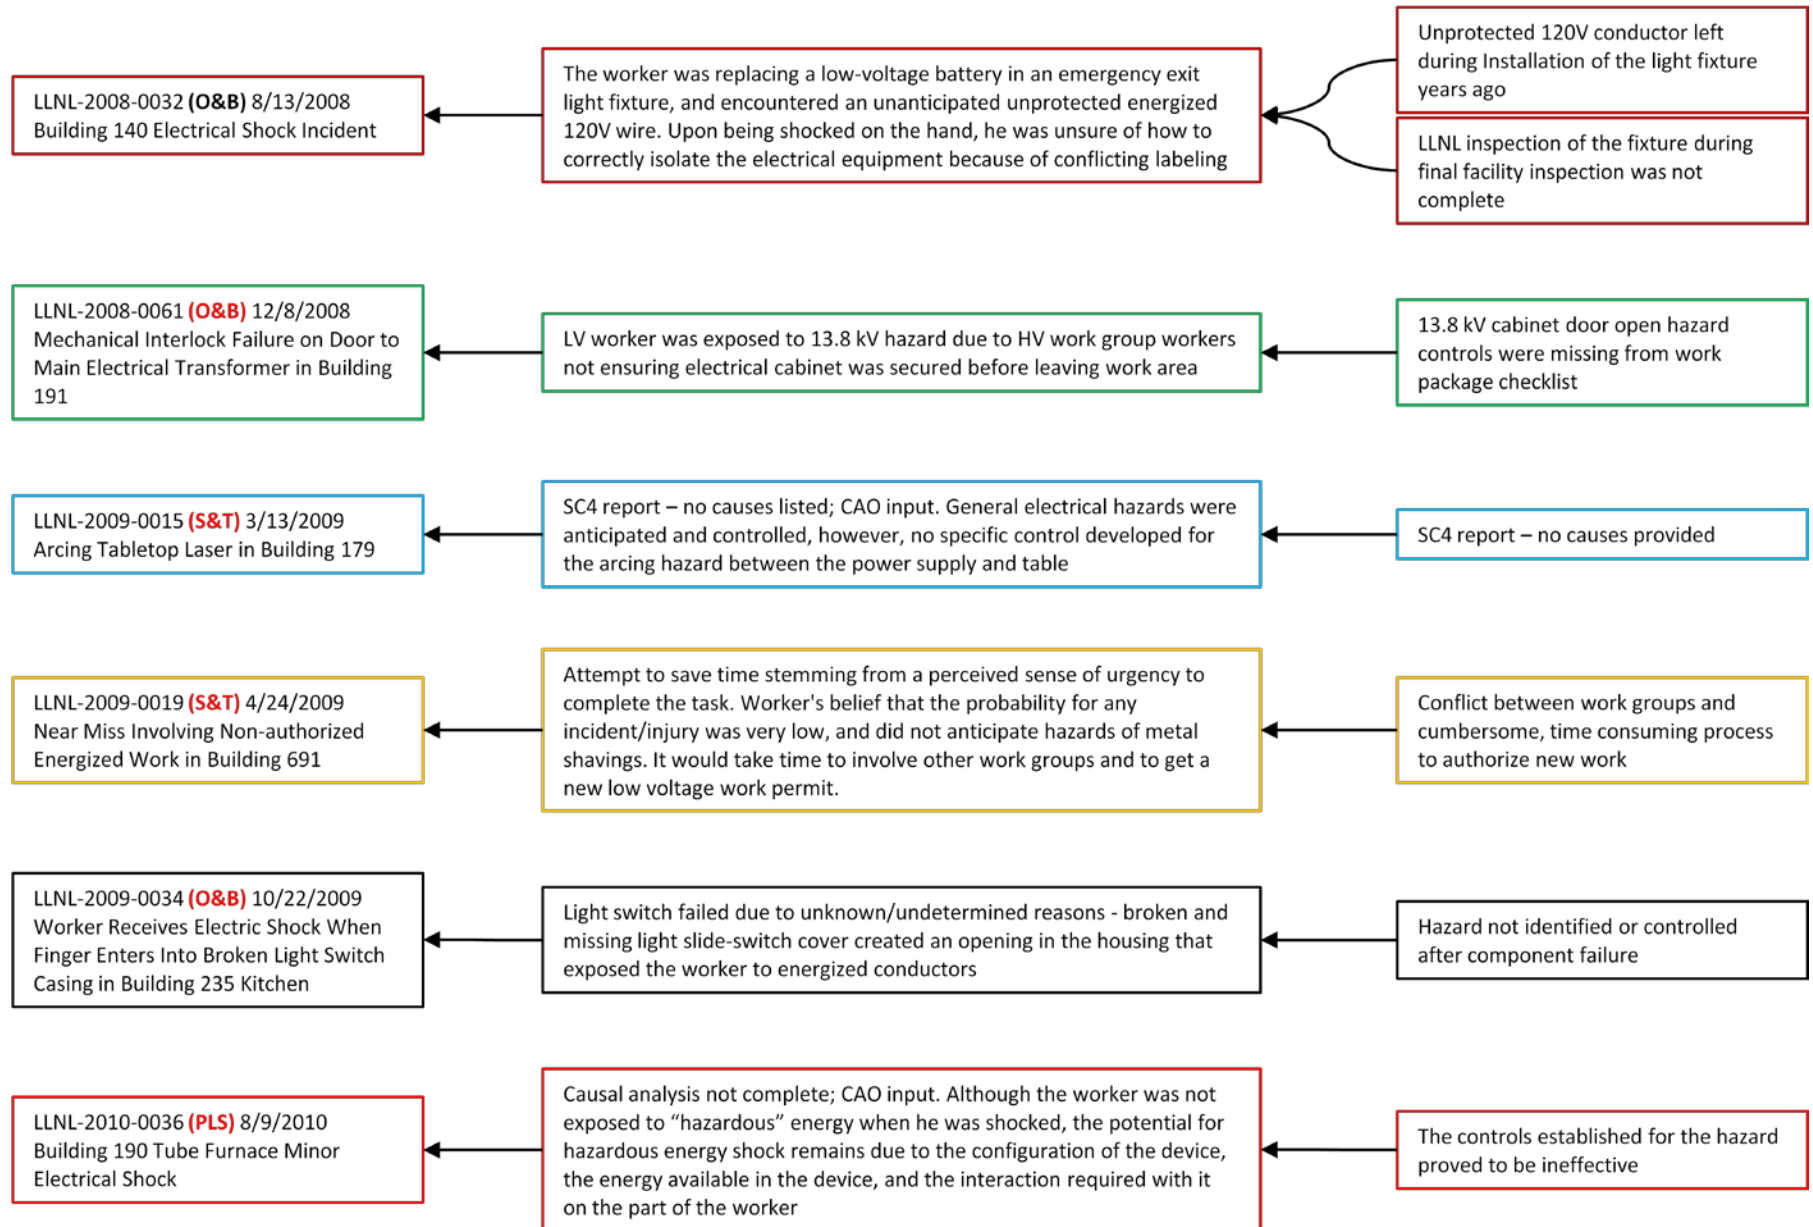
Figure 8. Common Cause Analysis of Events related to ISM Function 3: Develop and Implement controls

In these six events, the hazards associated with the work were not effectively controlled due to several factors: legacy hazards that were left by equipment installers and then accepted by LLNL during final inspection of work; incomplete check of work after completion leaving uncontrolled hazard for follow-on workers; conflict between work groups; a cumbersome, time consuming process to authorize new work; hazards not identified or controlled after component failure; and the controls established for the hazard proving to be ineffective.

In August of 2008, a worker was replacing a battery in an emergency exit light fixture in building 140. Upon opening the fixture access door and reaching inside, the back of his wrist came in contact with an unprotected 120V wire. The 120V unprotected energized wire had been left by the installation crew when the building was completed. This hazard was not discovered, and thus not controlled by LLNL inspection of the fixture during final facility inspection. The worker received a shock, and then capped the wire without performing a LOTO first (because of a conflict between drawings and schedules and a desire to leave the work in a safe condition). He was not injured.

In another event in December 2008, a low-voltage electrical worker was cleaning up a room that contained a 13.8kV electrical cabinet, and inadvertently hit the cabinet door with his broom, causing the door to open, exposing him to the energized components inside. The cabinet had been accessed by high-voltage workers earlier in the day. When the high-voltage crew left at the completion of their work, the crew did not ensure that the door was secured. The causal analysis determined that the proper controls were missing from the work package checklist.

In April 2009, a worker was removing empty metal conduit from a 480V electrical panel by using a metal saw. In doing so, conduit metal shavings were introduced into the panel from above where he was cutting the conduit – this created a serious arc-flash hazard that was not controlled. The causal analysis revealed that conflict between work groups and a cumbersome and time-consuming process to authorize new work were the direct causes of the event.

In another event, in October 2009, a worker attempted to turn on a light in a break room, and in doing so, came in contact with energized conductors that had become exposed on the bottom of the switch. A switch cover was broken and missing on the bottom of the cover, and the worker could not see this. The worker contacted 277V AC power, but was not injured. This hazard was not identified or controlled after the component failure.

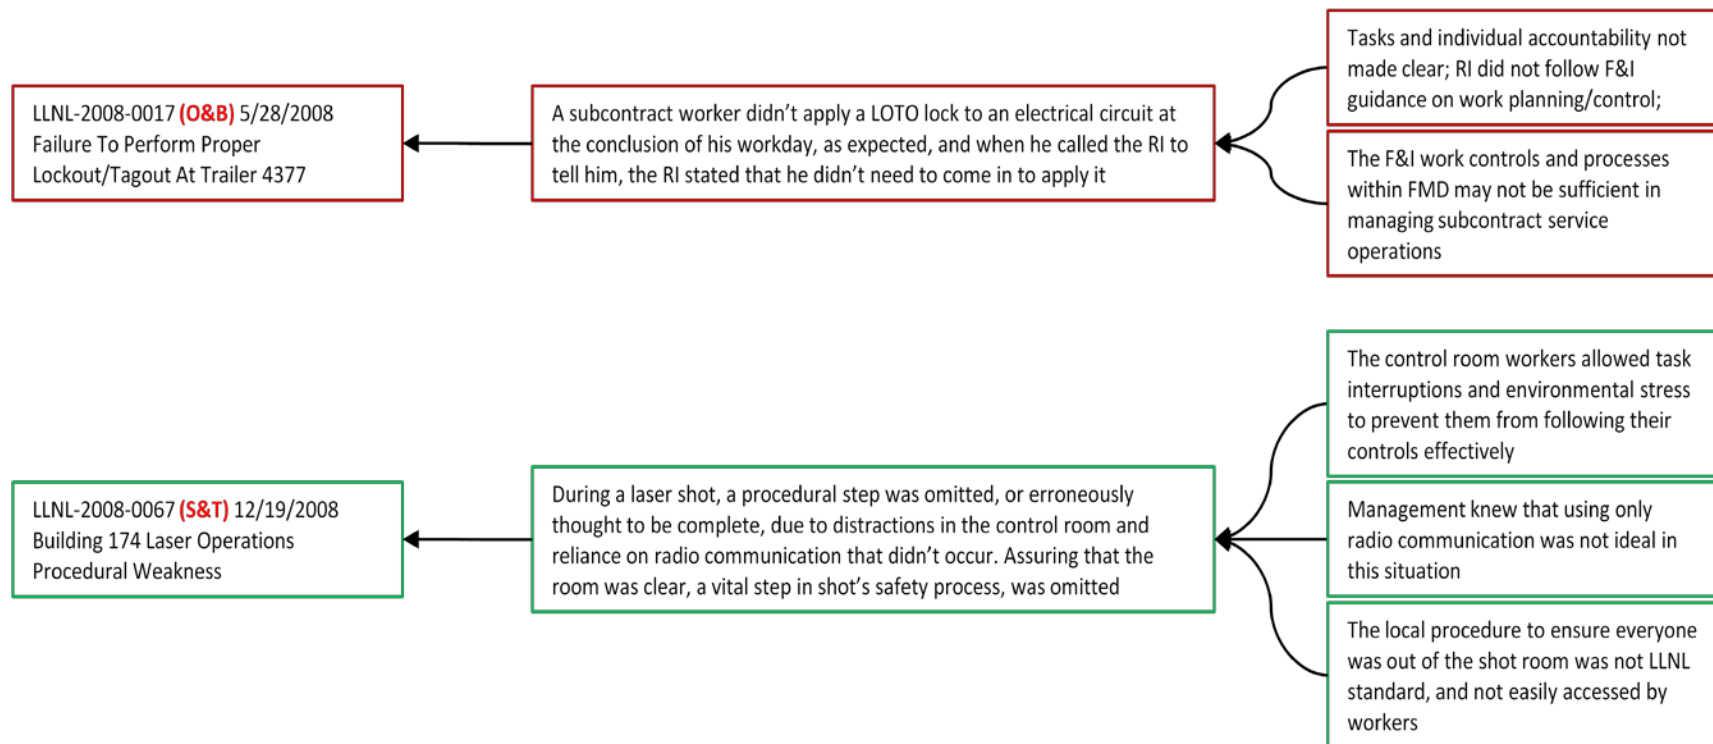
Figure 9. Common Cause Analysis of Events related to ISM Function 4: Perform Work

The causes indicate that work was not performed in accordance with work control procedures or guidance, due to the following factors: work task and individual accountability were not made clear to the worker; RI did not follow the directorate work planning guidance; directorate-level controls were not sufficient in managing subcontract work; workers allowed task interruptions and environmental stressors to prevent them from following control; an existing control that was still being used was known to be less than optimum; and local procedures that are meant to ensure the safety of the workers were embedded in a longer alignment procedure and were not easily accessed by the workers.

In the first event, in May 2008, a subcontract worker did not apply a LOTO lock to an electrical disconnect that controls an AC unit that he was working on. He left for the day, and upon remembering that he did not place the LOTO lock on the device, called the RI to tell him. The RI did not require that he return to place the lock, nor did he require another method of protecting the circuit, in accordance with the directorate's expectations. The causal analysis determined that the tasks and the individual accountability were not made clear to the worker, and the RI did not follow the directorate's guidance on work planning and control. The analysis also identified that the directorate may not have a sufficient process for managing subcontract service operations.

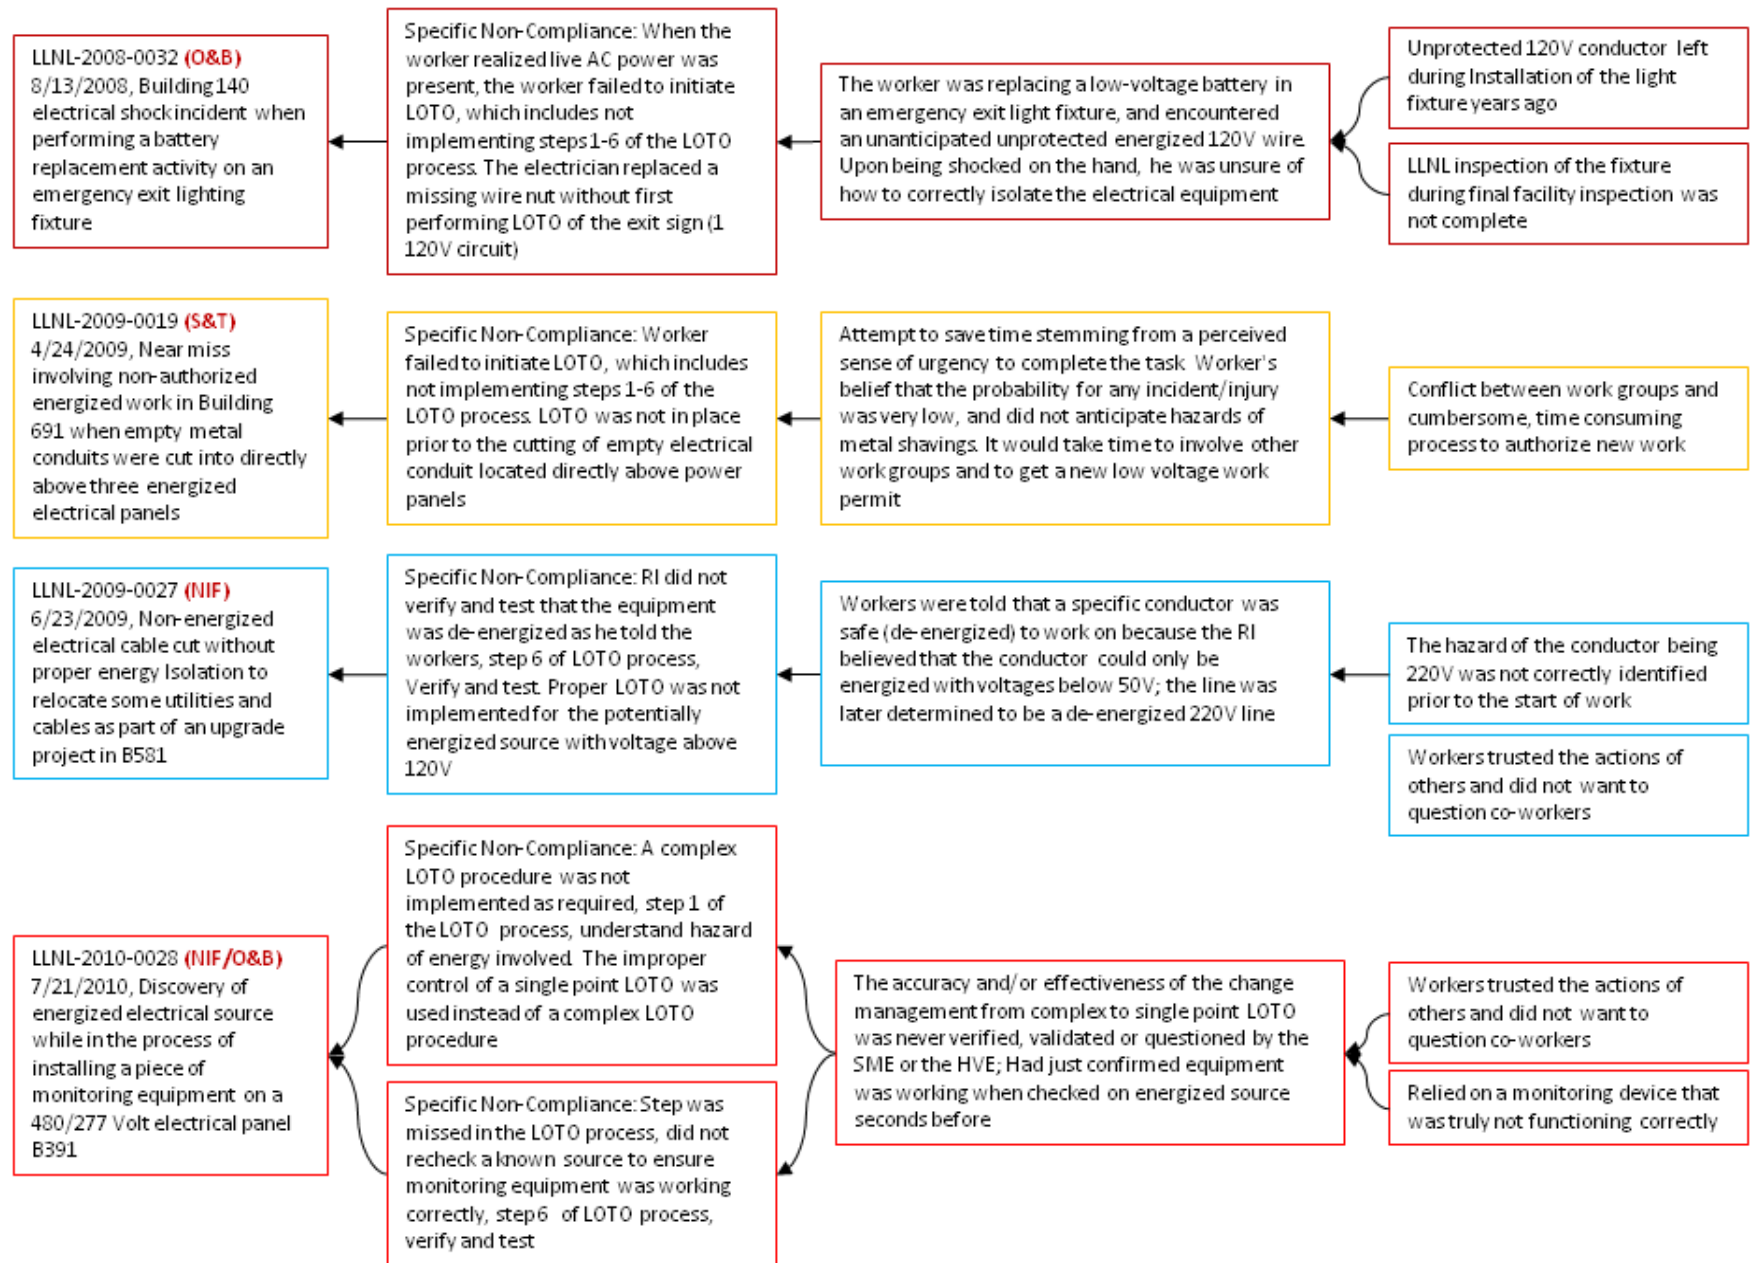
Figure 10. Common Cause Analysis of the Four Occurrences related to the Implementation of LOTO

The specific LOTO related noncompliance(s) with each of the four occurrences are shown in Figure 10.

The apparent causes of the four occurrences were as follows:

- The hazard was underestimated or not identified,
- Implemented controls were ineffective,
- Time consuming process to authorize changes,
- Hazards had been left uncontrolled and later discovered by another worker,
- Conflict between work groups,
- Workers trusted actions of others and didn't question or verify the directions given,
- Device not functioning correctly.
